## CASE STUDY: MARYLANDS ROAD (MAIDA VALE)

Falco was appointed by the Insurance Division of water utility firm the Lanes Group Plc to resolve a longstanding flooding issue in a residential district of Maida Vale.

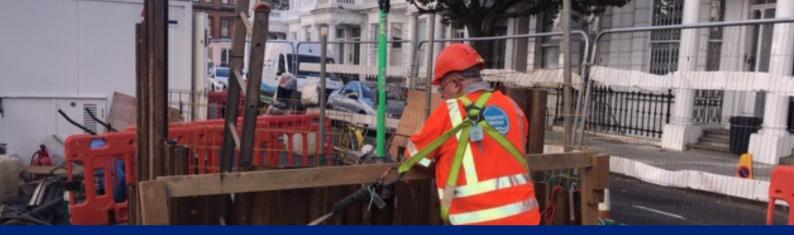
A camera survey had identified a broken drainage pipe beneath Marylands Road as the cause of the problem. Falco were instructed to gain access and undertake repair.

The works involved machine and manual techniques. Using a 14-tonne excavator we excavated a 2.4 sqm shaft to a depth of six metres in the carriageway and a 6.5 metre timber heading was hand-dug to locate the damaged pipe.

This was replaced with a new Vitrified Clay Pipe and connected to the mains trunk sewer. The timber heading was carefully backfilled with foam concrete and the shaft backfilled and reinstated.
